FIRE PERFORMANCE EVALUATION OF OCEANSAFE H10-FPS/FPS, IN ACCORDANCE WITH UNDERWRITERS LABORATORIES (UL) 1715, STANDARD FOR FIRE TEST OF INTERIOR FINISH MATERIAL

SwRI® Project No. 01.15216.01.207
Test Date: January 19, 2010
Report Date: February 8, 2010

Prepared for:
Oceansafe
3255 Bayshore Road
Greenport, NY 11944

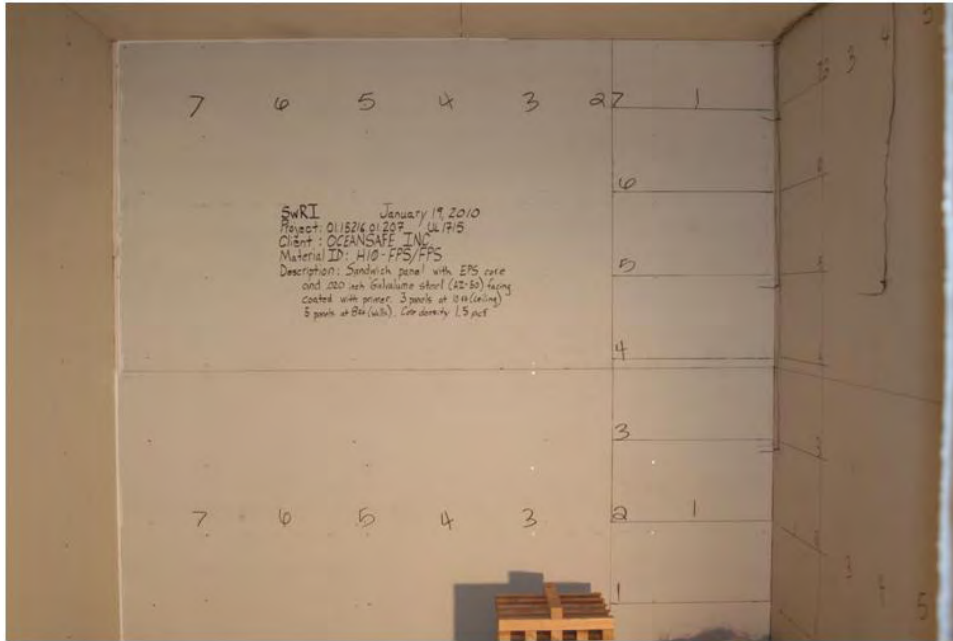
Figure 1. Completed Test Room.

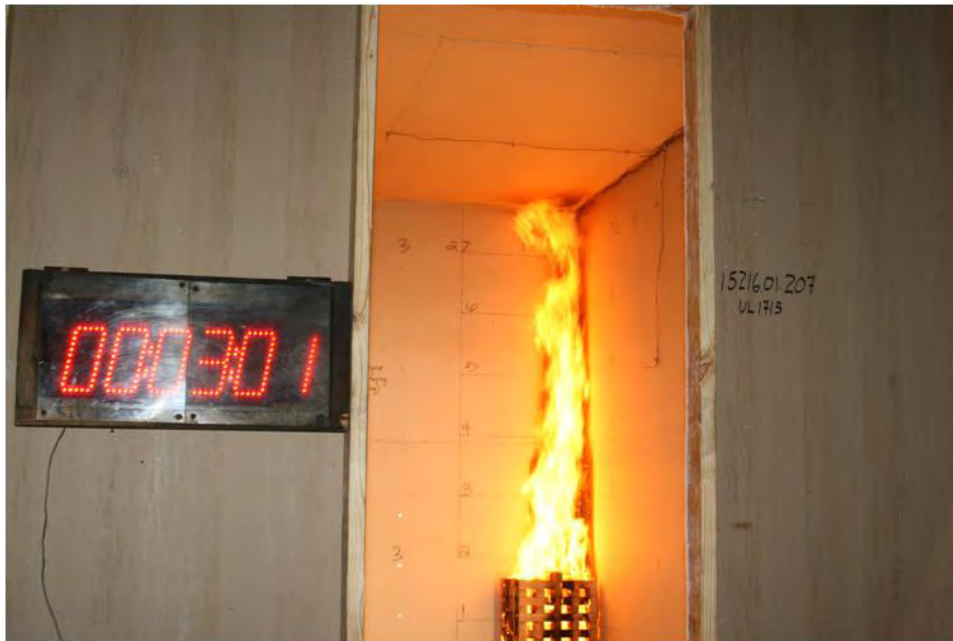
Figure 2. 3 min 1 s into Test.

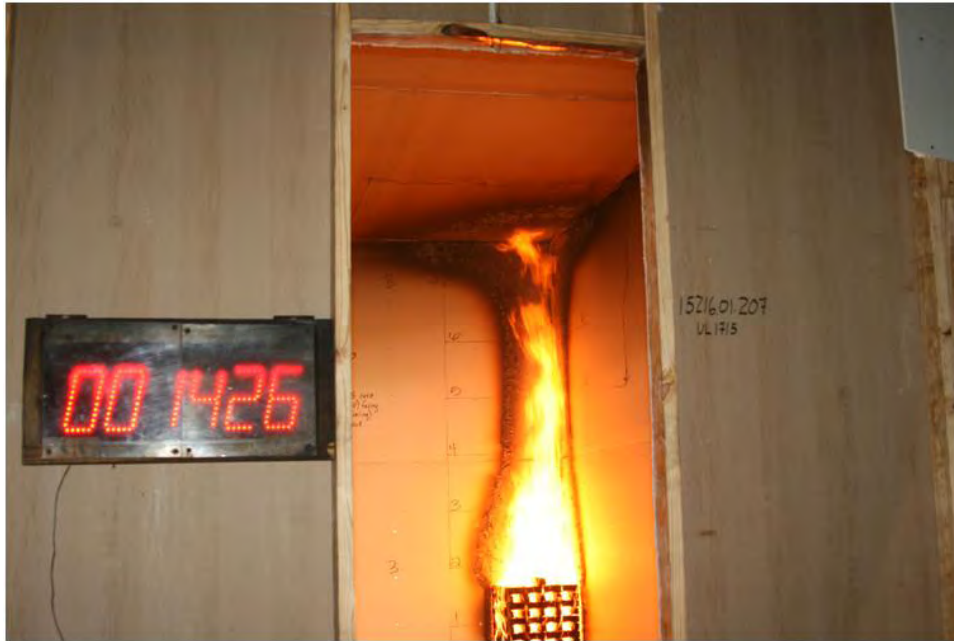
Figure 3. 14 min 26 s into Test.

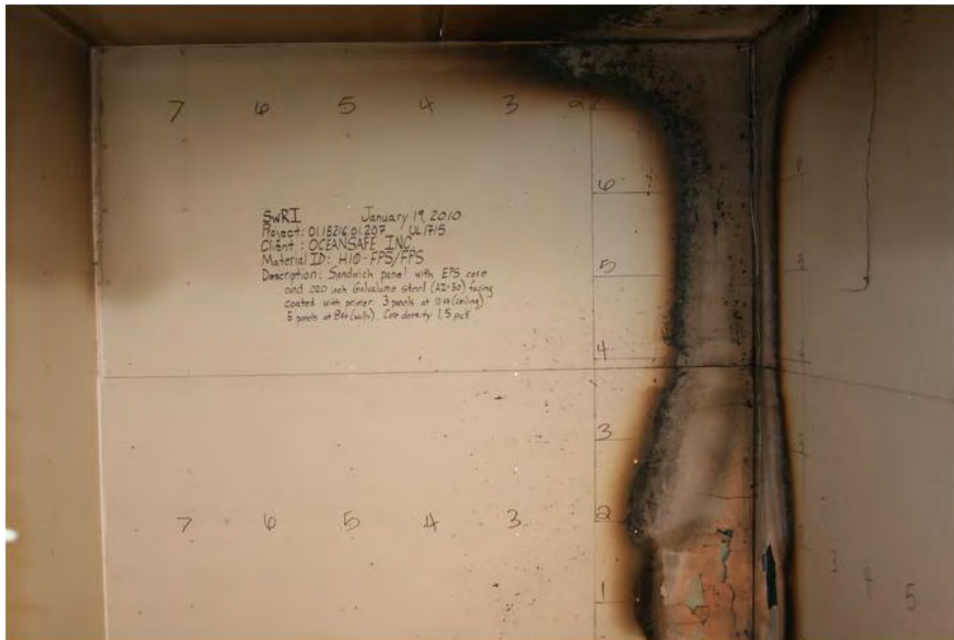
Figure 4. Post-Test View No. 1 of Burn Corner with Gypsum.

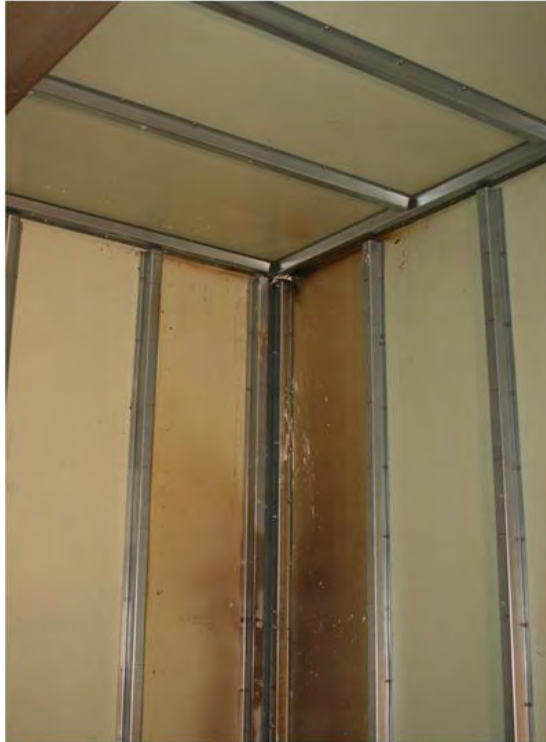
Figure 5. Post-Test View without Gypsum.

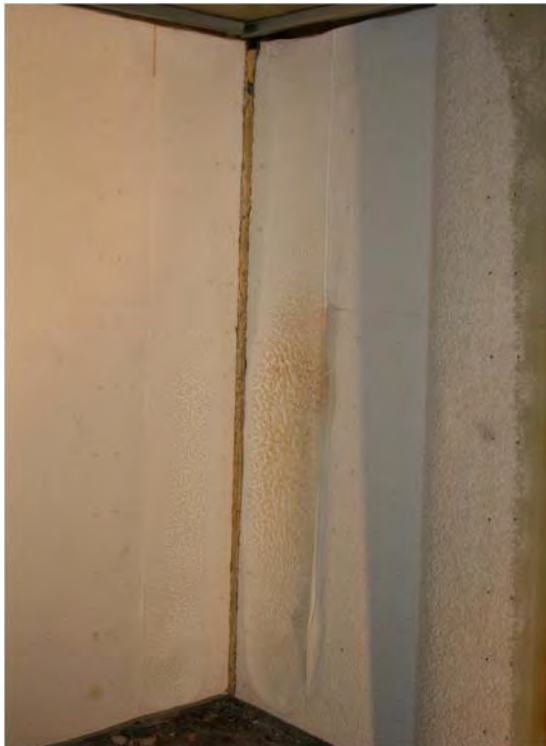
Figure 6. Post-Test View without Metal Sheeting.

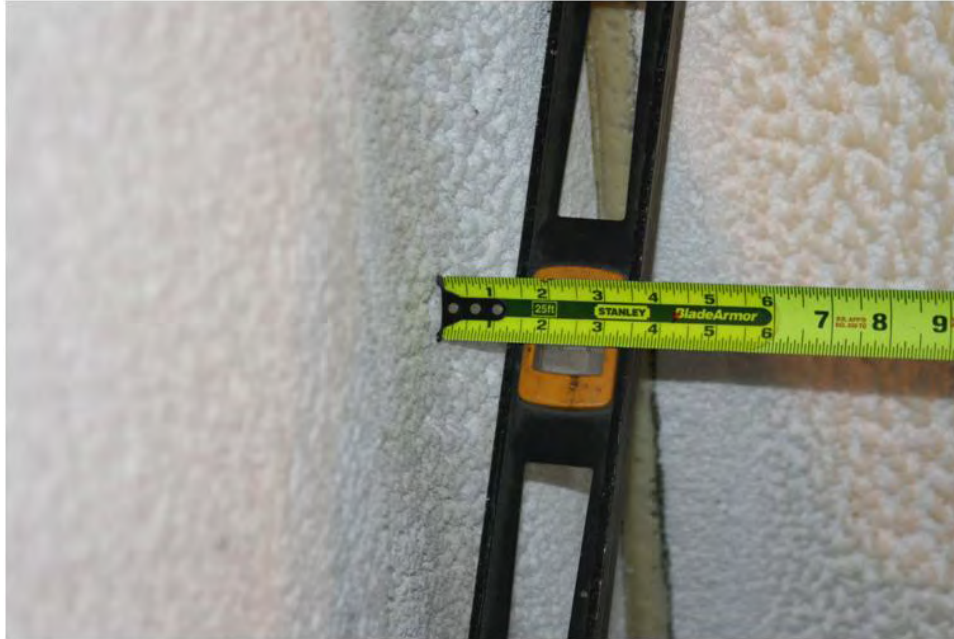
**Figure 7. Back Wall: Post-Test View without Metal Sheeting.
Nominal 1 3/8-in. Melting Depth at Crib Corner.**

Based on the test results, the material identified as *H10-FPS/FPS*, does comply with the statements in the *Performance* section of UL 1715 because surface burning did not extend to the extremities of the test specimen, and charring did diminish from the test corner to the outer extremities of the test walls and ceiling. Post-test investigation revealed no melting of the EPS on the ceiling and only minimal melting of the EPS on the back and right side test walls (See Figures 7 and 8.).

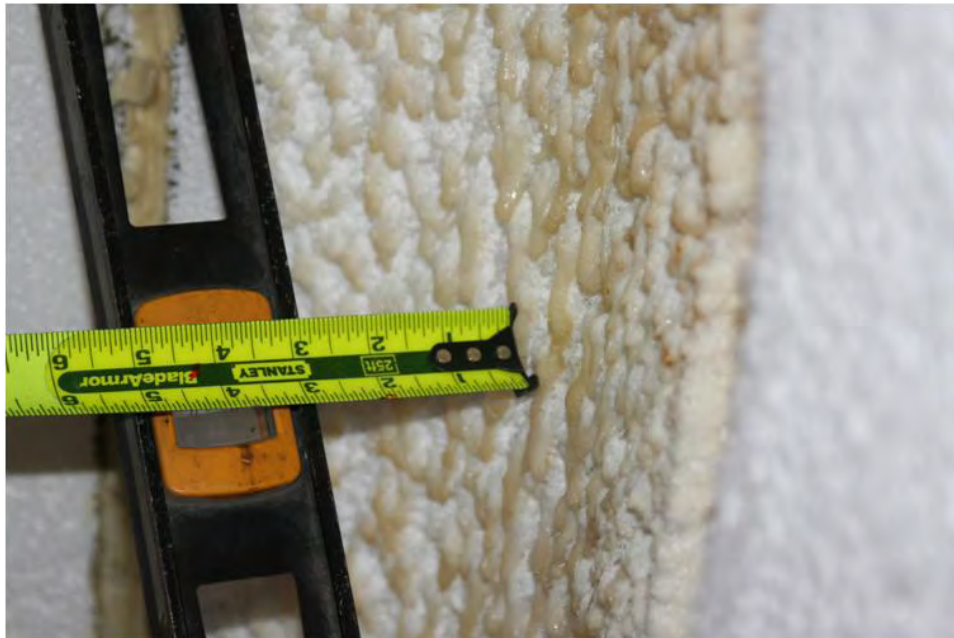
**Figure 8. Right Wall: Post-Test View without Metal Sheeting.
Nominal 2 3/4-in. Melting Depth at Crib Corner.**

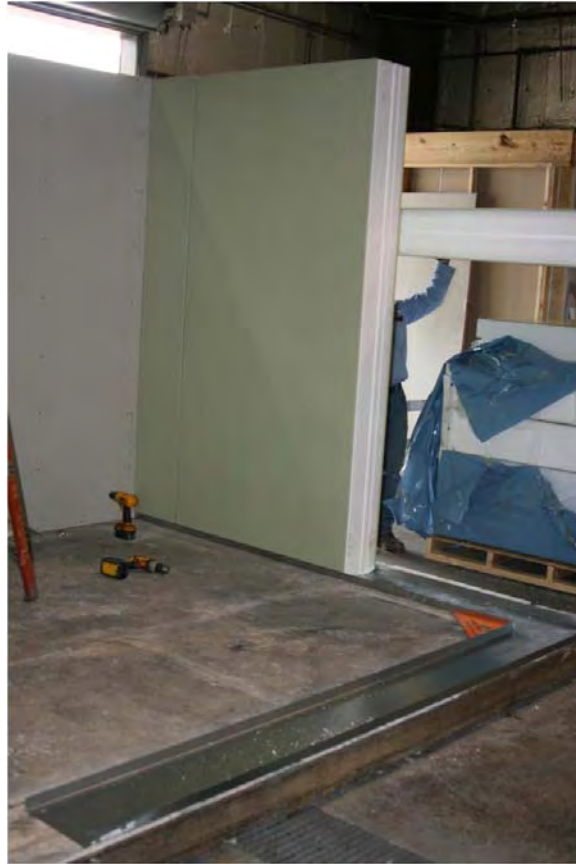
Figure 9. Open C Channel and Test Wall Construction.

- 2.) The 8-ft panels were placed on end and pressed together via interlocking channels (See Figure 9.).
 - 3.) This was repeated until all panels were snap fit together.

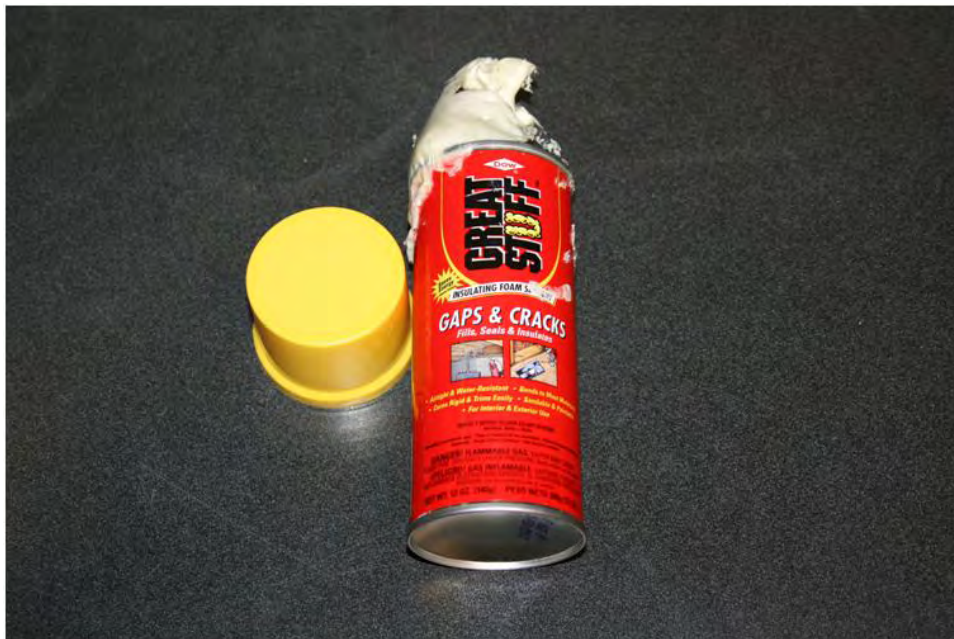
Figure 10. Single-Component Polyurethane Foam Sealant.

- 6.) The gap in the test corner where the two walls were joined, was filled with an insulating single-component polyurethane foam sealant (See Figure 10.).

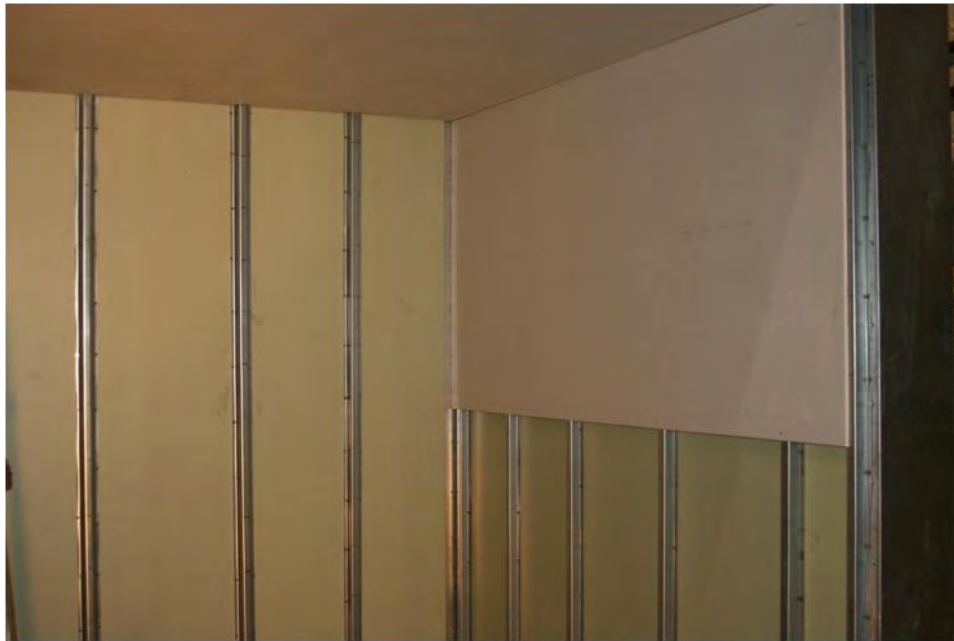
Figure 11. Walls with 1½-in. Furring Strips and Regular ½-in. Thick Gypsum Lining the Interior.

- 9.) 1½-in. furring channels were installed to the inside of the test walls and ceiling, spaced every 24 in.
 - 10.) Once the furring channels were in place, one layer of regular ½-in. thick regular gypsum wallboard was fastened to the interior of the test walls and ceiling (see Figure 11). The nominal finished interior dimensions of this module are 8 × 12 × 8 ft high. Both test walls and ceiling screw patterns were 8 in. on center.

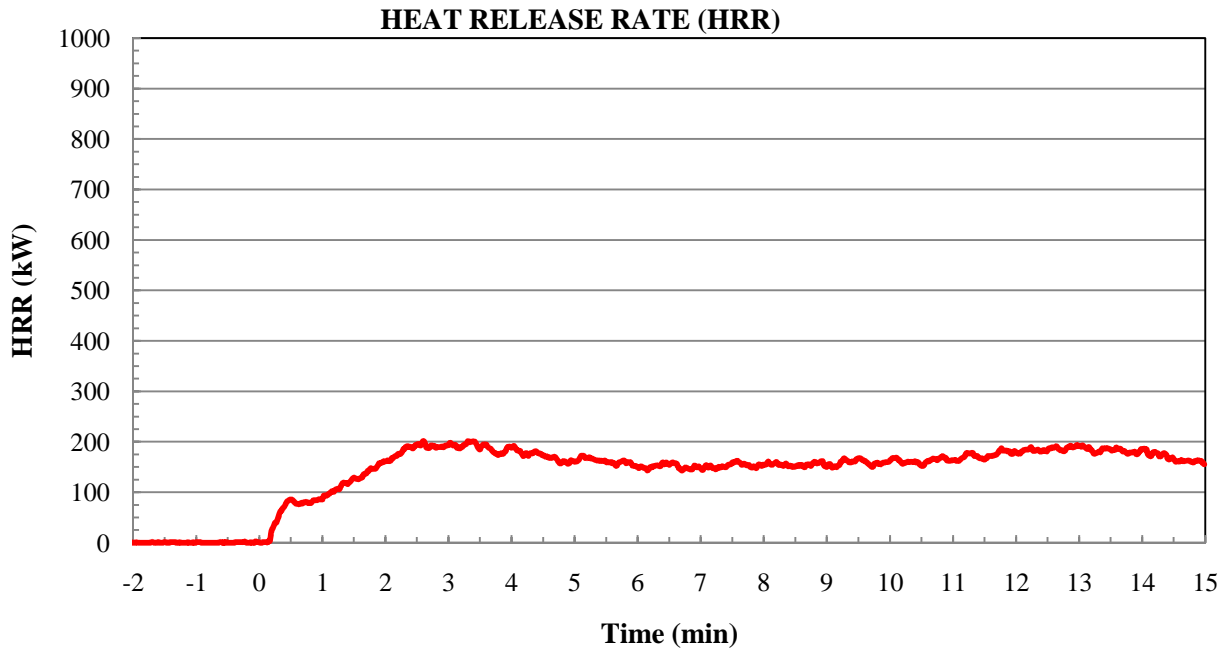
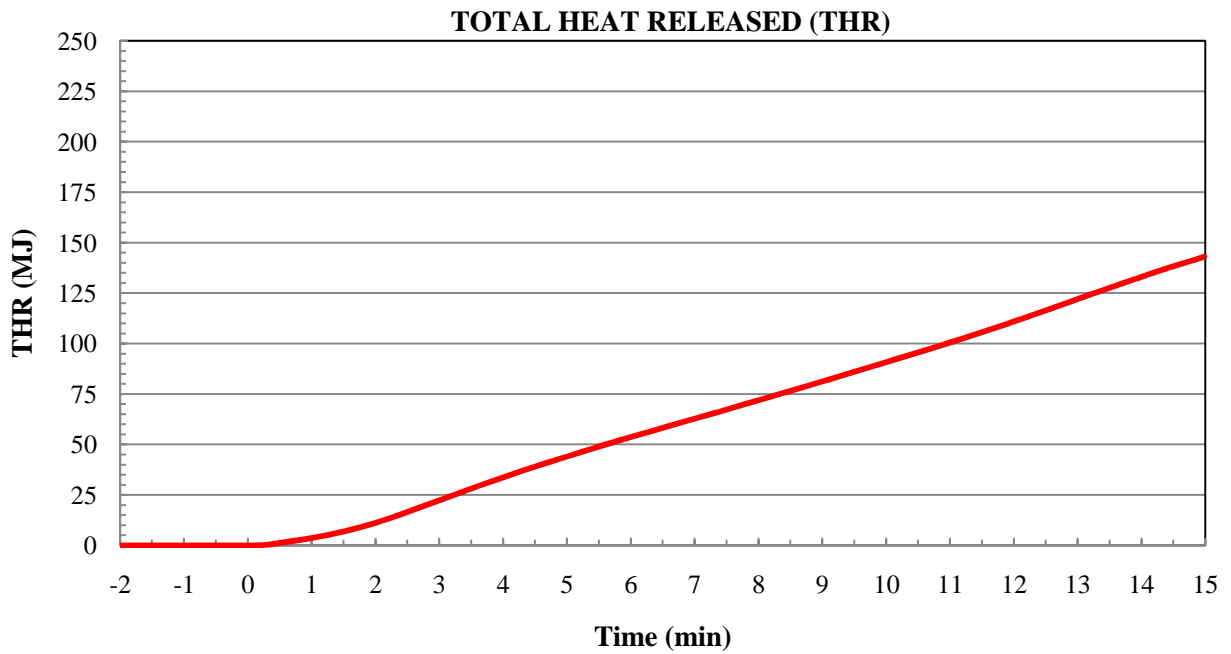
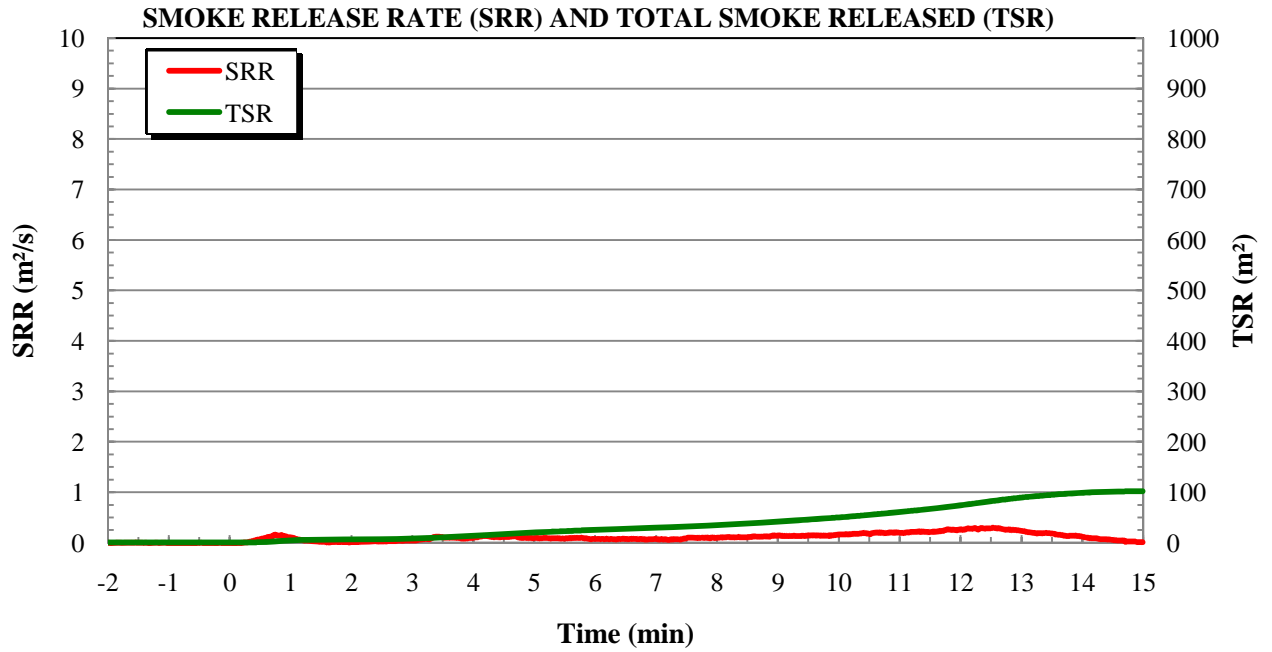
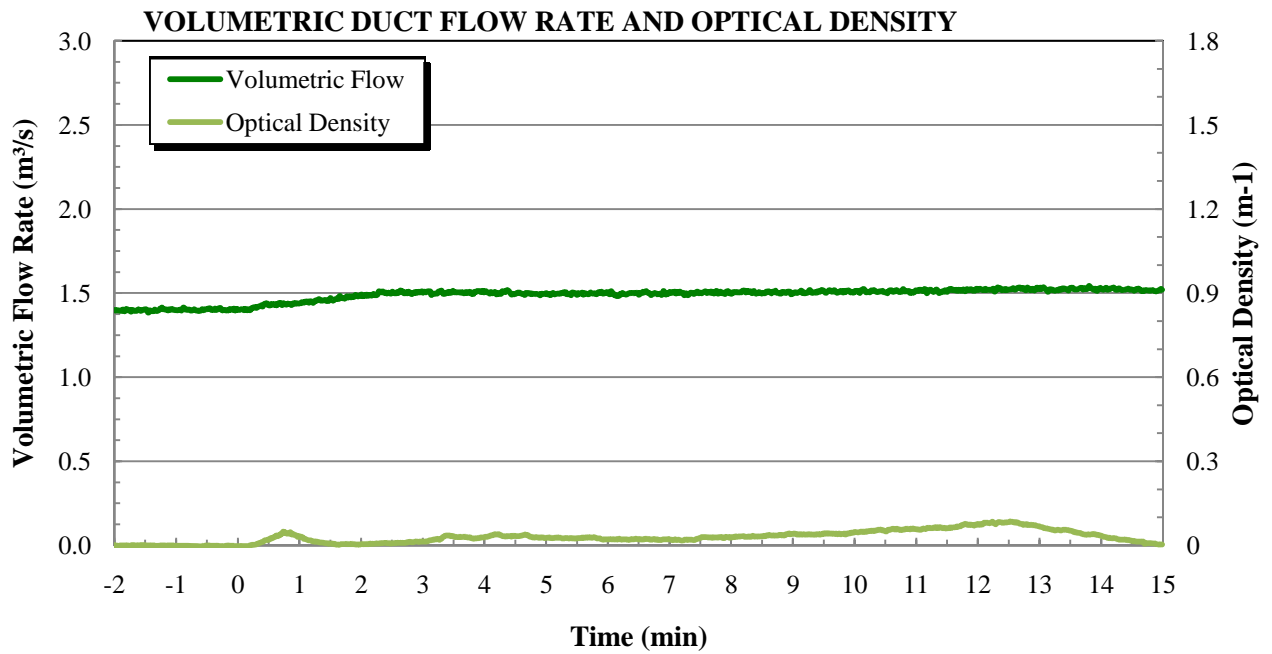
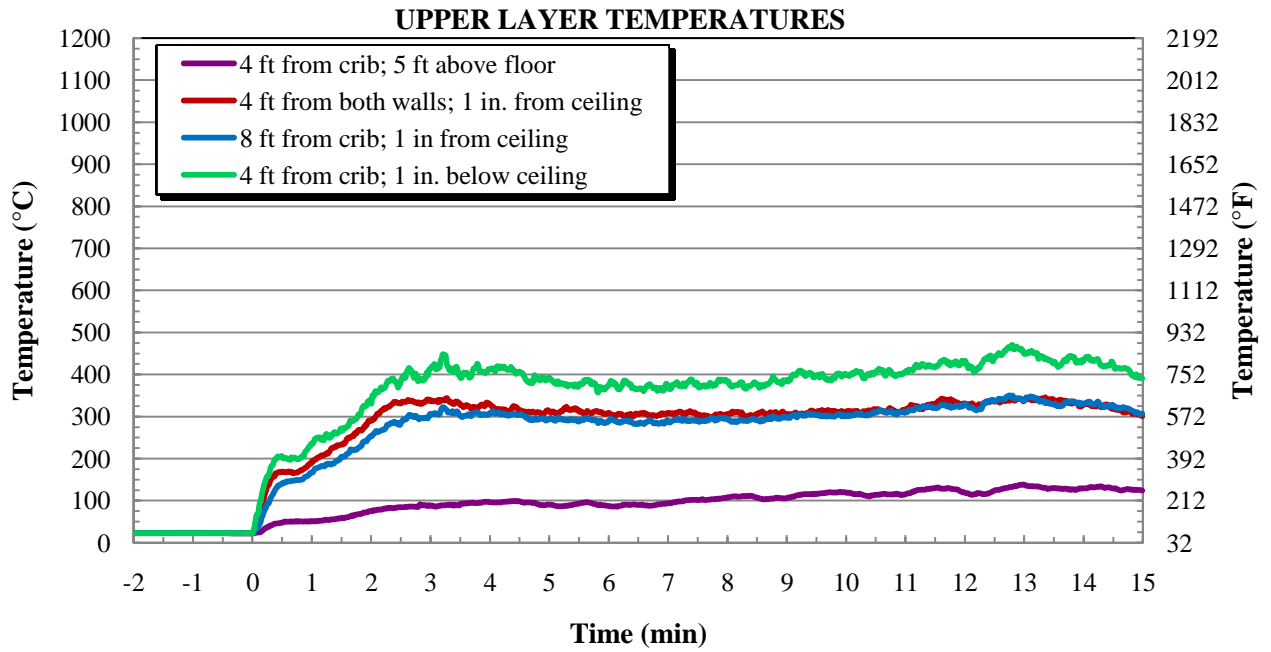
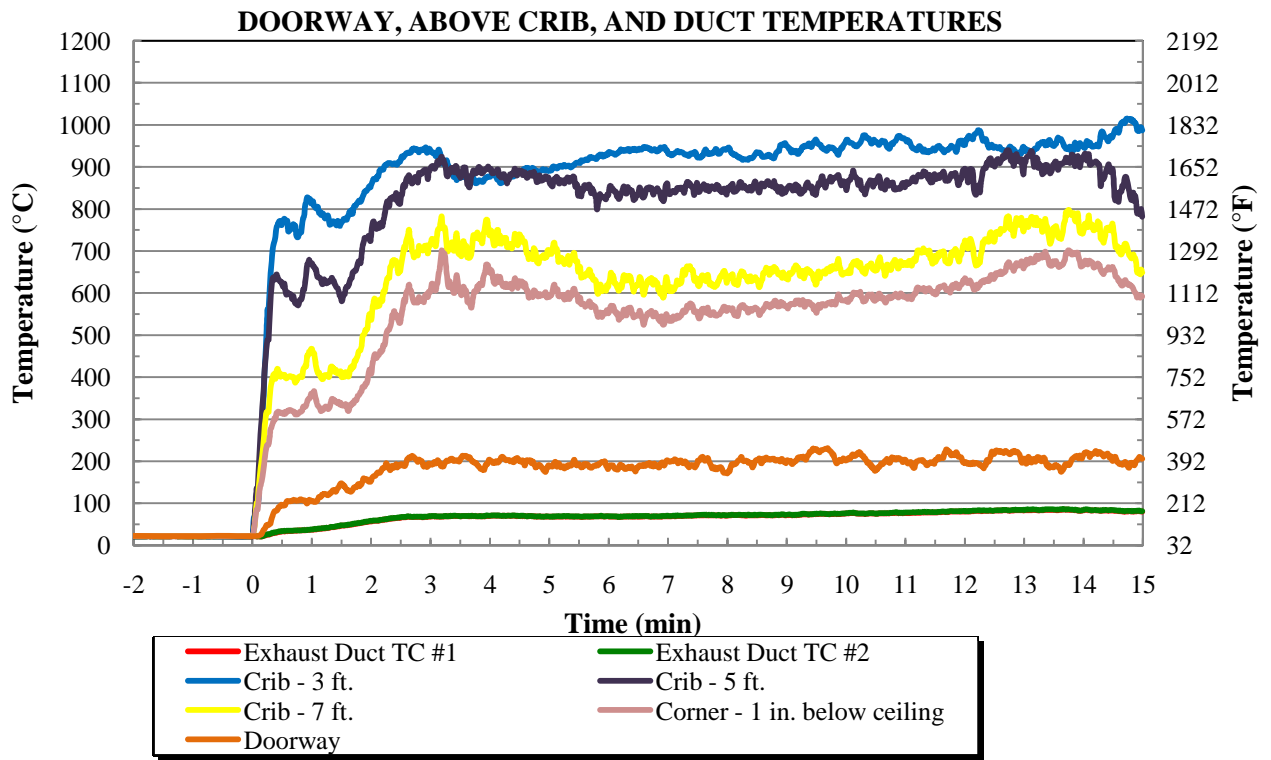
**SUMMARY OF
TEST RESULTS**

Maximum HRR _{total}	202 kW	at 2:36
Average HRR _{total}	159 kW	
Total Heat Released	143 MJ	
Maximum Smoke Release Rate	0.30 m ² /s	at 12:31
Average Smoke Release Rate	0.11 m ² /s	
Total Smoke Released	102 m ²	
Maximum Optical Density	0.085 l/m	at 12:31
Maximum Duct Flow Rate	1.54 m ³ /s	at 13:48
Average Optical Density	0.033 l/m	
Average Volumetric Duct Flow Rate	1.50 m ³ /s
